COST Action FP1004 Final Meeting

# Shake table tests on a full-scale timber-frame building with gypsum fibre boards

Daniele Casagrande, Paolo Grossi, **Roberto Tomasi** Department of Civil Environmental and Mechanical Engineering, University of Trento, Italy

**SERIES PROJECT** (Seismic Engineering Research Infrastructures for European Synergies)

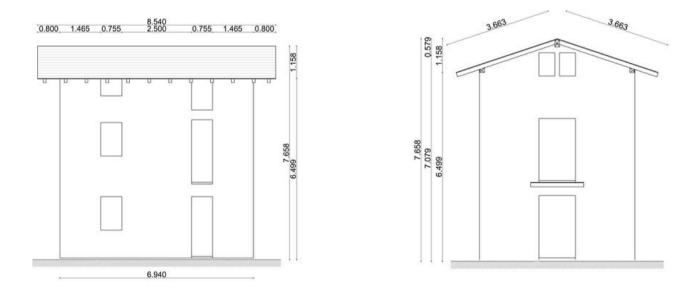
### Specimens geometry

All specimens had the same geometry (squared 7 m x 5 m) and architectural layout.

- TF/CLT three storey to a maximum height to the peak of 7.65m
- LH two storey to a maximum height to the peak of 5.28m

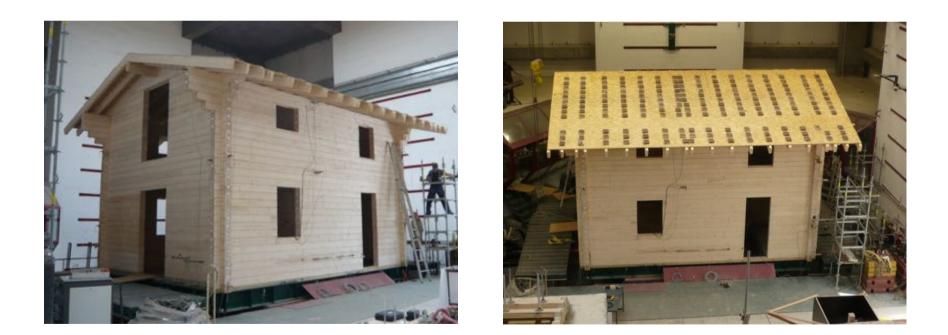
### Log house specimen

The **log house** specimen has been produced by the Portuguese company Rusticasa. According to the present production standard of the company only two storeys have been built, with a maximum height of 5.28 m at the ridge.

Walls	Inner walls logs 80x160 mm Outer walls logs 160x160 mm
Floor	Timber beams 90 x 165 mm + 15 mm OSB sheathing panels, ring nails (2.8 x 60 mm) Connection between walls and floors is obtained by means of dovetail joints
Roof	Solid wood rafters (70 mm x 190 mm), over which OSB panels are nailed The ridge board has a 120 mm x 200 mm cross-section
Connections	The sill logs are connected to the steel plate through M16 bolts, class 8.8

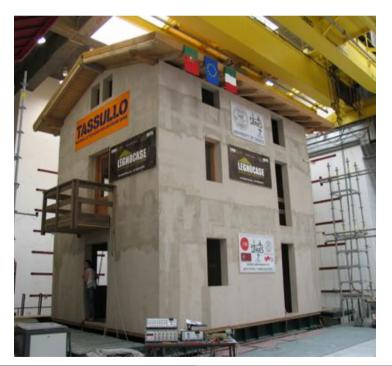
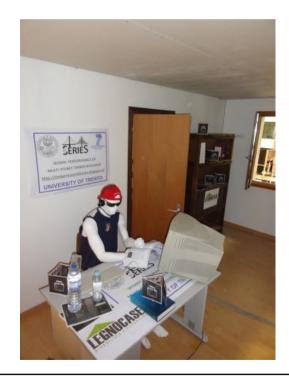
### Light timber framed wall specimen 1

Two different timber frame specimens were tested. The first one, with **OSB structural sheathing panels**, has been produced by the Italian company Legnocase. The structure was completed with external and internal claddings and one room of the 2nd storey was also equipped with laminate floor - drywall and ceilings – doors - windows and furnitures.

Walls	light frame walls (60/100x160 mm studs and 60 mm top/bottom beams) OSB sheathing panels
Floor	600 mm x 140 mm modular Timber box elements (beams 78x31 mm upper and lower boards 31 mm) + 15 mm OSB sheathing panels nailed with ring nails 2.8x60 mm) Connection between walls and floors is obtained by means of screws
Roof	Solid wood beams rafter 100x140 mm/760 mm, ridge beam 160x240 mm, purlins 160x160 mm. Wooden plank (20 mm) reinforced with perforated metal strips
Connections	Shear connections: steel plate (anker nails 4x60 mm) Uplift connections: tie-downs (anker nails 4x60 mm) Base shear connections: screws 8x180 mm Base uplift connections: hold-downs (anker nails 4x60 mm)

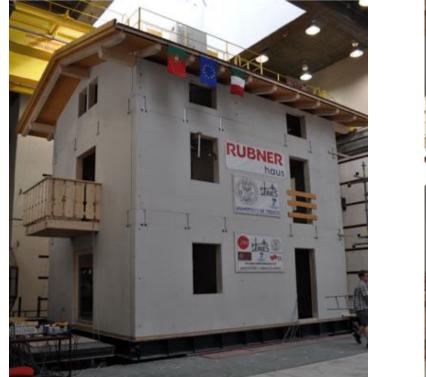
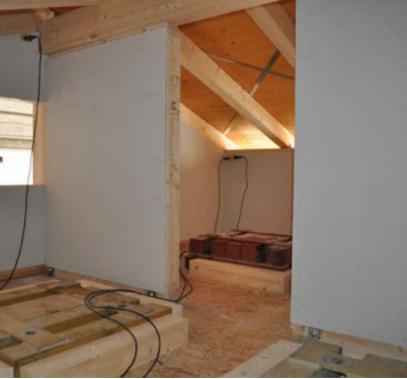
### Light timber framed wall specimen 2

The second TF building, produced by Italian company Rubner\_haus, was built with **gypsum fibre structural sheathing panels** connected to the timber frame of the walls by means of steel staples (instead of using the system OSB + ring nails).

Walls	light frame walls (80x120/160 mm studs and 60 mm top/bottom beams) Gypsum fiber sheathing panels
Floor	Timber beams 80x200 mm + 12 mm OSB lower panels and 22 mm OSB upper panels (all panels nailed with ring nails 2.8x60 mm) Connection between walls and floors is obtained by means of screws
Roof	Solid wood beams rafter 120x160 mm/840 mm , ridge beam 160x240 mm, purlins 160x240mm. Wood planks (20 mm) reinforced with perforated metal strips
Connections	Base shear connections: angle brackets (anker nails 4x60 mm) Base uplift connections: hold-downs (anker nails 4x60 mm)
CONTECTIONS	Shear connections: angle brackets (anker nails 4x60 mm) Uplift connections: tie-downs (anker nails 4x60 mm)

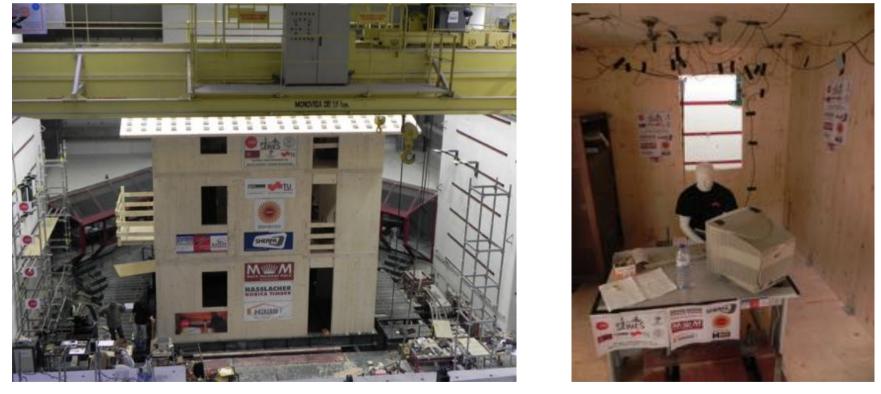
### **Cross laminated timber specimen**

The last test of Timber Building project within SERIES was carried out on **CLT** three storey building. In this case all the elements (walls, floors, roof) were built with cross laminated timber panels of different thickness.

Walls	3 layers CLT wall panel 100 mm (layup 30-40-30)
Floor	5 layers CLT floor panel 150mm (layup 30-30-30-30-30). Connection between walls and floors is obtained by means of screws
Roof	3 layers CLT floor panel 99mm (layup 33-33-33). Connection between walls and roof panels is obtained by means of screws
	Base shear connections: angle brackets (anker nails 4x60 mm) Base uplift connections: hold-downs (anker nails 4x60 mm)
Connections	Shear connections: angle brackets (anker nails 4x60 mm) Uplift connections: hold-downs (anker nails 4x60 mm)

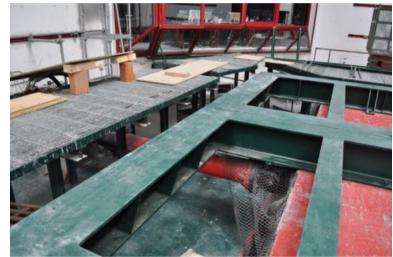
### LNEC Shaking table

To test real scale lightweight timber structures the size of the table (5.6x4.6 m) was enlarged with a structural base frame (5x7m) made of steel beams bolted on the top plate.

Steel plates, anchored to the floor, reproduces the weight according the load combination for seismic load cases (self-weight of flooring and a fraction of variable load ).

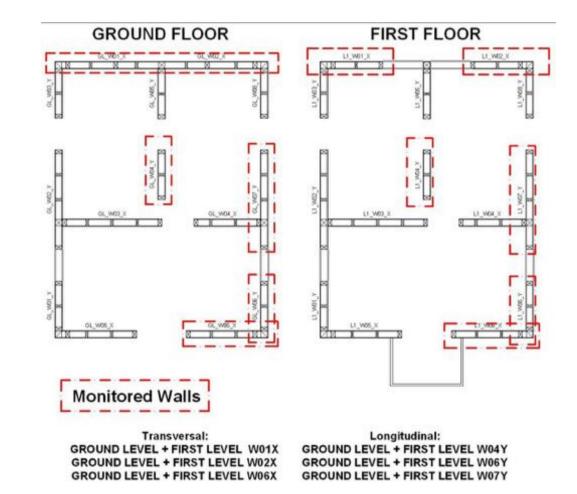
### Instrumentation

Туре	Qty	Measure
LVDT	4	Inter-storey drift
LVDT	8	Wall sliding
LVDT	10	Wall uplift
Accelerometers on structure	39	Accelerations at different levels and
Accelerometers on steel basement	5	Accelerations at the shaking table level positions
Load cell	10	Forces on hold down anchoring elements
Optical displacement measurement system 1	5	Point absolute displacements (5 points x,y component)
Optical displacement measurement system 2	20	Point absolute displacements

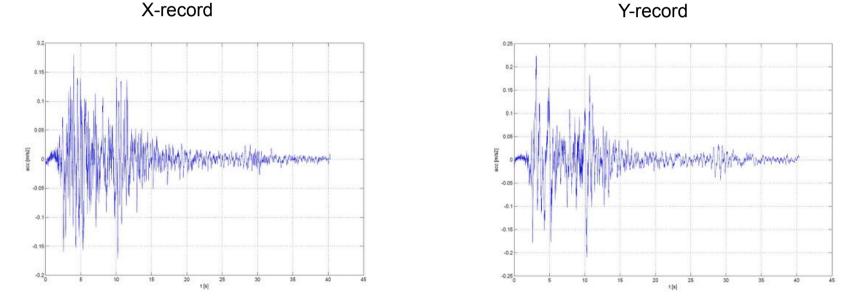
### Input signal

The accelerograms were recorded at the station "Ulcinj - Hotel Albatros" located at an epicentral distance of 21 km during the Montenegro earthquake of 15/04/1979 (Mw 6.9).

The values of peak ground acceleration (PGA) at which the buildings were been tested, at different stages of

### tests, ranged from 0.07g to 0.5g.

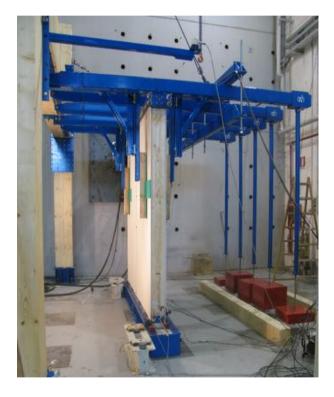
### Preliminary tests on full-scale walls

The mechanism failure of the wall was related to the oligo-cyclic fatigue failure of the staple legs.

Therefore, in tested wall, the sheathing-to-framing connection represents the weakest component of the structural system.

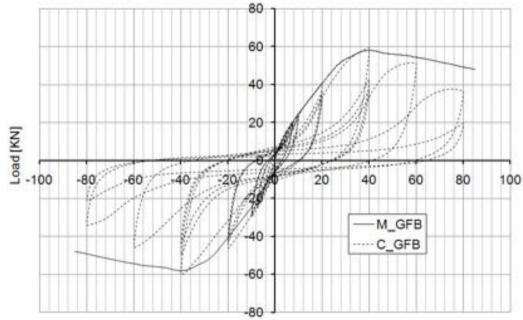
### Preliminary tests on full-scale walls

Imposed horizontal displacement [mm]

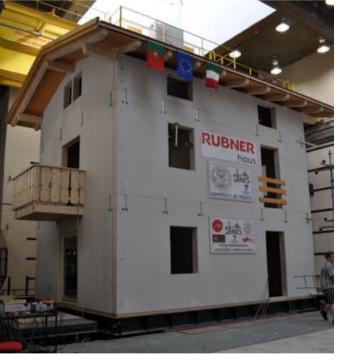
### Shake table test: two different stages

### **UN-WEAKENED BUILDING**

The input signals was scaled from 0.07 g to 0.50 g along the longitudinal direction (Y) of the specimen

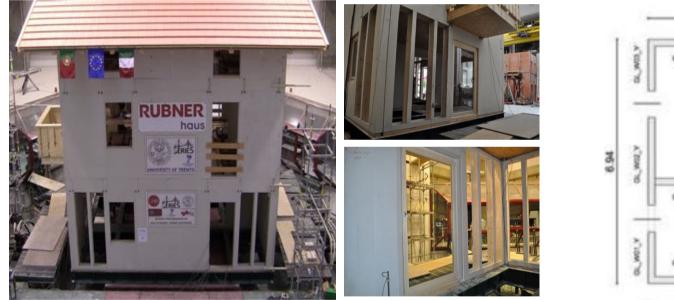
WEAKENED BUILDING

This operation leads to a "new structure" where the lateral load bearing system of the ground floor is reduced keeping the same capacity for vertical loading.

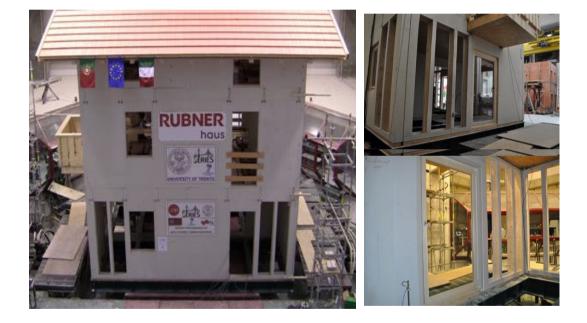
### WEAKENED BUILDING

Label	Typology	Targ-x	Targ-y
15	Dynamic id.		
D9	Seismic test		
D10	Seismic test	0.06g	0.07g
D11	Seismic test	1000000	
T5	Seismic test		
16	Dynamic id.	1.2	
D13	Seismic test	0.40-	0.15g
D12	Seismic test	0.12g	
Τ6	Seismic test		
17	Dynamic id.		
D14	Seismic test		
D15	Seismic test	0.23g	0.28g
D16	Seismic test	0000000000	100000
17	Seismic test		
18	Dynamic id.		
D17	Seismic test	1020200	
D18	Seismic test	0.40g	0.50g
D19	Seismic test		
19	Dynamic id.	2.40	
T8	Seismic test	0.40g	0.50g
110	Dynamic Id.		
T9	Seismic test	0.53g	0.66g
111	Dynamic id.

The input signals was scaled from 0.07 g to 0.66 g along the longitudinal direction (Y) of the specimen

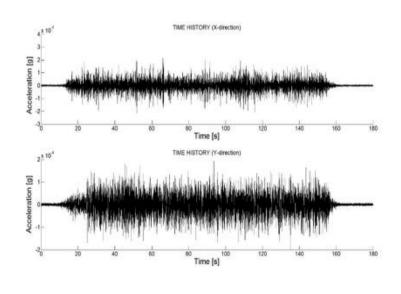
#### **Dynamic identification**

After each step of the test a dynamic identification of the model was performed (noise signal with a RMS of 0.05g and a frequency range between 0.1 and 30hz in order to get **natural frequencies and mode shapes**.

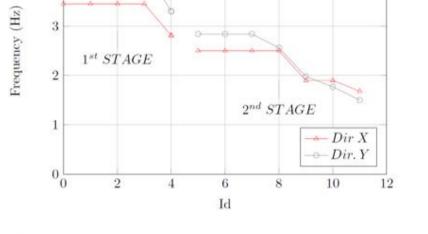
#### Analysis of results – natural frequencies

With the aim of detecting any damage of the structure a dynamic identification test was carried out after every target T seismic test.

Since a variation of modal properties was observed after the seismic tests of the stage (test I4), we can assume that <u>the dynamic</u> <u>behaviour of the building in the stage 2 had</u> <u>been influenced by the stage 1 seismic tests.</u> For this reason the un-weakened building, despite of no visible damage was detected by visual inspection, cannot be considered as a "new" building

10	11	12	13	14	15	<b>I</b> 6	17	18	19	110	<mark> 11</mark>
1st x	3.45	3.45	3.45	3.45	2.81	2.50	2.50	2.50	2.50	1.90	1.90	1.68
1st y	4.18	4.18	4.18	4.18	3.30	2.84	2.84	2.84	2.56	1.98	1.77	1.50

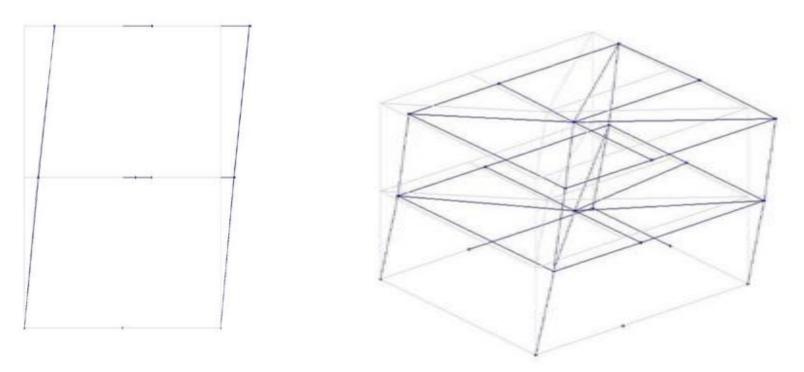
Un-weakened TRANSVERSAL X 3.45 Hz

Analysis of results – mode shapes

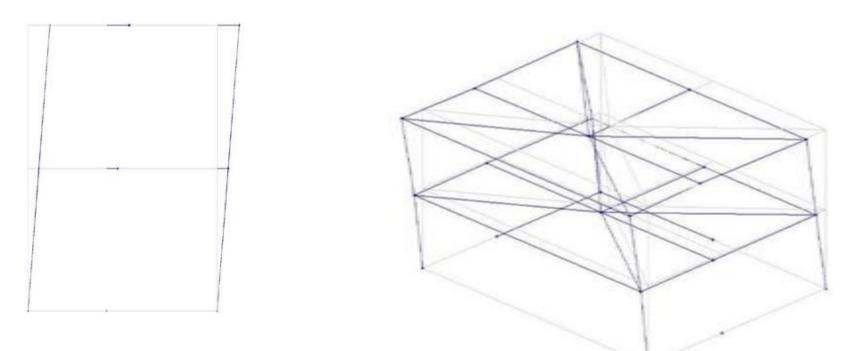
Un-weakened LONGITUDINAL Y 4.18 Hz

Analysis of results – mode shapes

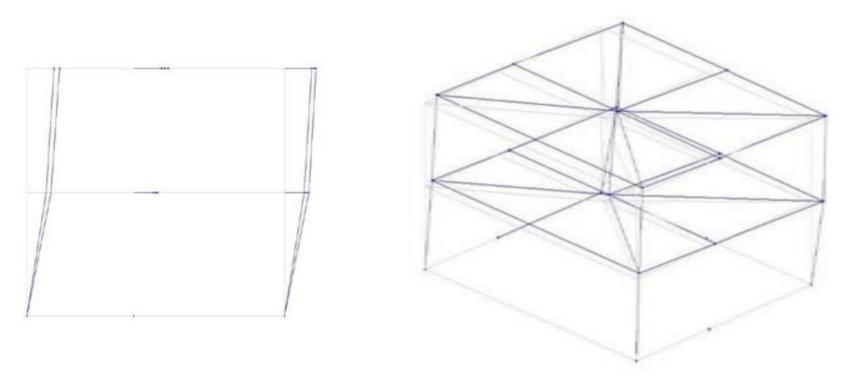
Weakened LONGITUDINAL Y 2.84 Hz

Analysis of results – mode shapes

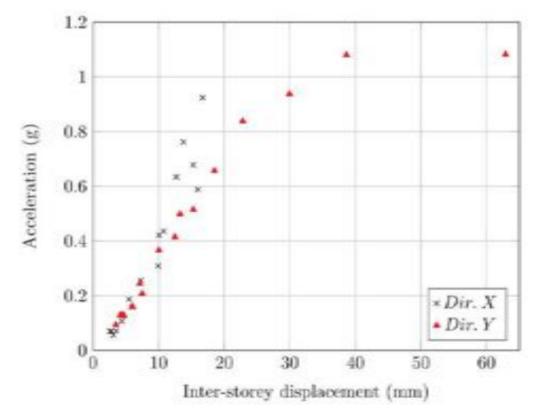
Analysis of results – peak acceleration vs inter-storey drift

#### Weakened

a significant reduction of the curve slope shown for displacement greater than 30 mm, confirming a strong nonlinear behaviour of the structure in the last tests.

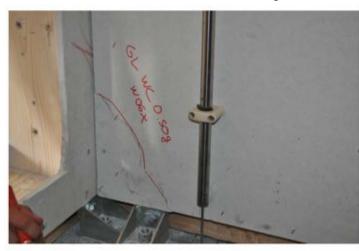
D19 0.50 g

#### Analysis of results – visual inspection

Test	Detected damage							
D19	Cracking of GFB in the proximity of the hold down anchor (W06_X, north east bottom corner), cracking on gypsum wallboards at corners of openings at the ground level (W01_Y, south east - W02_Y, south - W06_X, north east), cracking on the GFB at the ground level (W_06_X, north), spalling of the bottom edge of the GFB (W07_Y, north) at the ground level.							
T8	Cracking on the GFB at the ground level (W_07_Y, north – W04_X, central), cracking of the bottom comer of the GFB (W07_Y, north) at the ground level.							
Т9	Spalling at the corner of the window (W_06_Y, north), staples pull through (W_07_Y, north), cracking of GFB in the proximity of the hold down anchor (W04_X, north east bottom corner), cracking on the GFB at the ground level (W_07_Y, north)

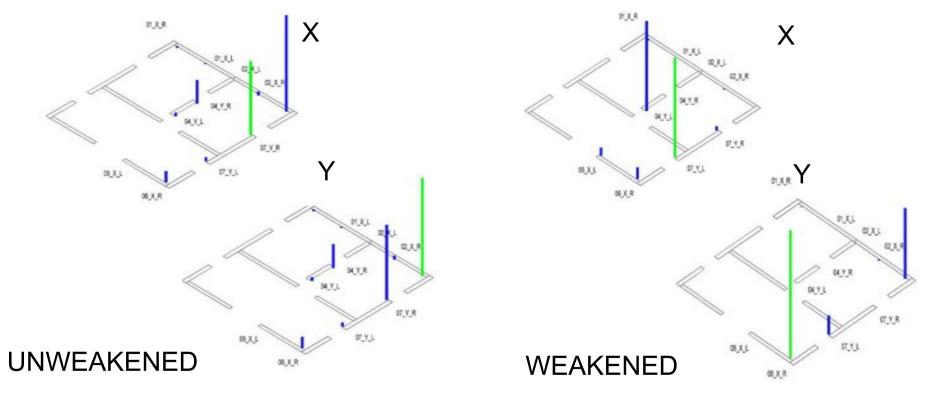
0.50g - Simultaneous values [kN]

These values are quite lower than the strength obtained from laboratory test (equal to 62 kN), confirming that the structural damage was related to the sheathing-to-framing connections and GFB.

Analysis of results – Tensile Forces in Hold-downs

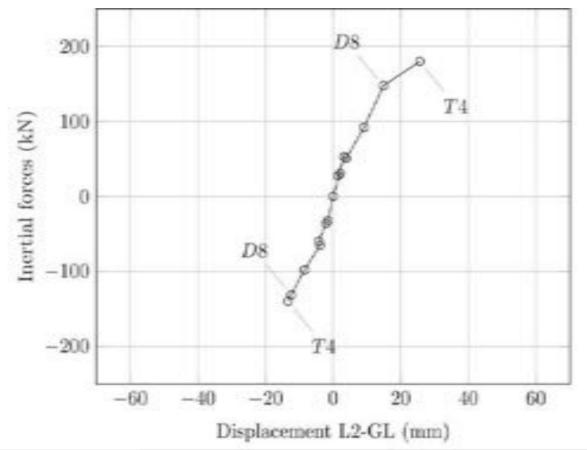
#### Unweakened

Analysis of results – Capacity spectra

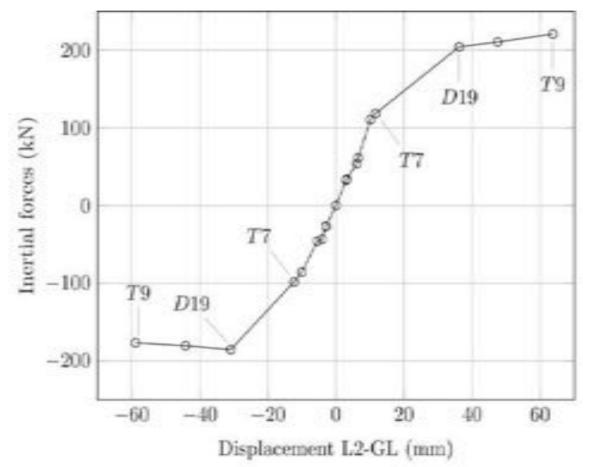
#### Weakened

Analysis of results – Capacity spectra
