COST Timber Bridge Conference – CTBC 2014

25–26 September 2014
Bern University of Applied Sciences
Biel, Switzerland

COST TIMBER BRIDGE CONFERENCE CTBC 2014

ISBN 978-3-9523787-4-8

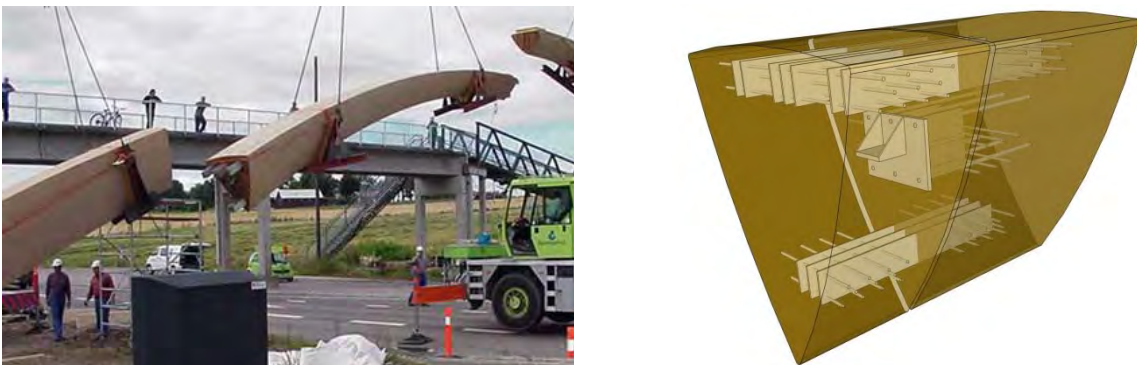
Figure 2: Leonardo Footbridge (2001), Norway, left: the central arch under assembling, right: 3D model of the splice joint

On the contrary, there are not many examples of splice joints carrying bending moments. Figure 2 presents a moment-resisting splice joint used in Leonardo Footbridge, Norway. Slotted-in steel plates and dowels at top and bottom edge together with a shear key placed in the middle of the sections are implemented to carry bending moments and shear force respectively. The shear key consists of welded steel gusset connected to timber by a combination of transversal dowels and rods glued-in from the end face. Axial compression force is transmitted by contact of end faces since gap between elements is filled with acrylic mortar. Weathering degradation and creep of acrylic mortar is a common concern because additional contraction of mortar overloads dowels which are not designed to carry axial force. However, a direct contact of timber end faces would set a high requirement on manufacturing precision, and in reality, there will always occur a surface inaccuracy to some extent between such large elements. Regular inspection of joint is therefore important. Upper sides of Leonardo footbridge arches were later protected by metal cladding to prevent water from leaking into possible gaps or cracks.

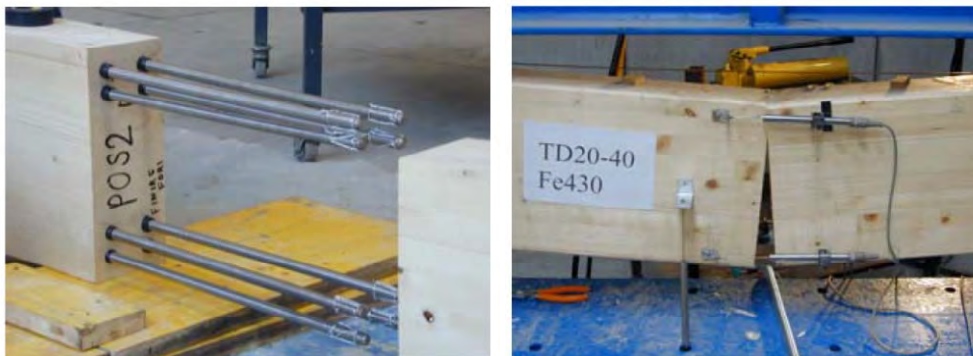
Figure 3: Splice joint with glued-in rods, left: rods glued into one member of the joint, right: plastic deformation of the joint, [9]

Load transfer from rods embedded lengthwise to timber is characterized by a good “flow-of-forces”. Stress distribution is provided by means of shear force continuously along the rods. The rods are fully embedded in timber members and thus protected. The predrilled holes are filled with epoxy resin and there is therefore no clearance between bars and wood. Initial slip is thus avoided. High strength epoxy resins are available on market. High stiffness and pull-out capacity is hence achieved. For large joints, multiple rods are necessary and brittleness of adhesive could lead to a progressive failure in a group of rods. Ductile behaviour is therefore very important. Series of bending tests with different layout of fasteners have been carried out by N. Gattesco et al. and results are presented in [9]. A very ductile behaviour was achieved by using low grade steel bars for monotonic tests. However, for cycling loading, after the yielding point of bars is reached and bars are subjected both to tension and compression, instability failure occurs by lateral bending of bars. As a result, brittle failure of timber in lateral direction is developed.

The shortcoming of usage of glued-in rods is a production difficulty. In the above shown example, rods were put inside holes using a wire guide to centre them. The epoxy was injected through holes drilled perpendicularly to each embedment hole near its end. For large glulam sections, more rods placed in one layer beside each other would be necessary making the injection of bars not placed near edges difficult. Effectiveness of the grouting operation cannot be visually checked. Experience in reviewing failed joints due to inadequately mixed and incorrectly applied epoxy on site limits the production to a climate controlled environment with quality control and skilled personnel [10]. E. Gehri presents in [11] a jointing technique combining glued-in bars and pinned steel connections. The principle of this so-called GSA[®]-technology is shown in the Figure 4. Rods are glued to timber sections in factory conditions with welded or screwed special steel pin-joint at the end. Pinned steel-to-steel connection is thus created with very fast on-site mounting. The ductile behaviour is achieved by a combination of low-grade steel and pre-defined glue-free deformation zone of rods. Uneven distribution of forces in a group

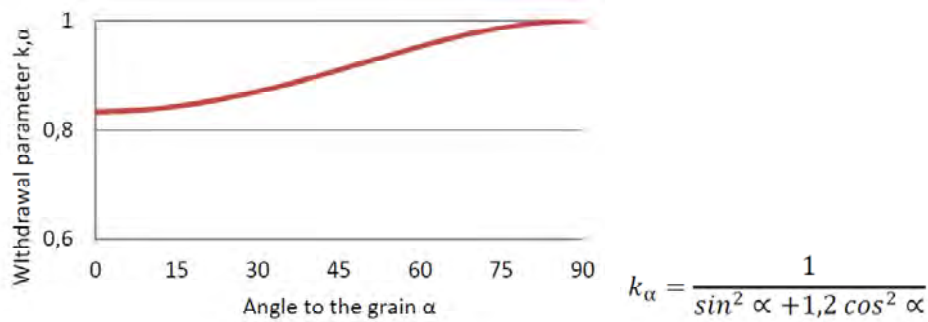
Figure 6: Hankinson function as used in Eurocode 5, amendment A1

Screws and threaded rods are intended to be axially loaded since they show great withdrawal and pushing-in resistance. Proper positioning of fasteners relative to the direction of grains and loads significantly affects both load-carrying capacity and stiffness of the connection. Withdrawal capacity at an angle to the grain is described by the Hankinson function used as a basis for equation (8.38) in Eurocode 5 (in amendment A1) [8]. In the Figure 6, the reduction of withdrawal capacity relative to the angle to the grain is demonstrated by a fictive factor k_{α} . It should also be mentioned that Eurocode 5 [8] only provides the design values for both withdrawal and pull-through resistance of screws for the angle to grain $\alpha \geq 30^\circ$.

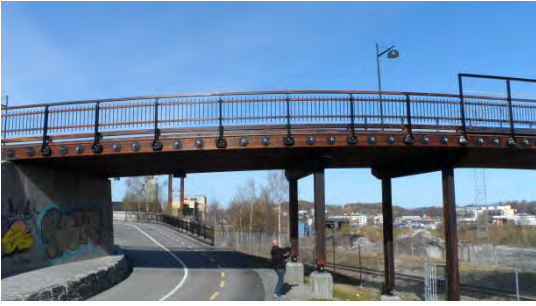
Figure 2: Bridge with one row of pre-stressed rods

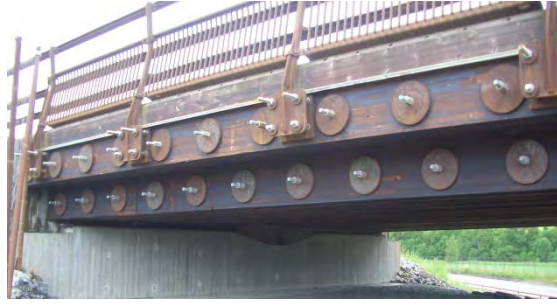
Figure 3: Bridge with two rows of pre-stressed rods

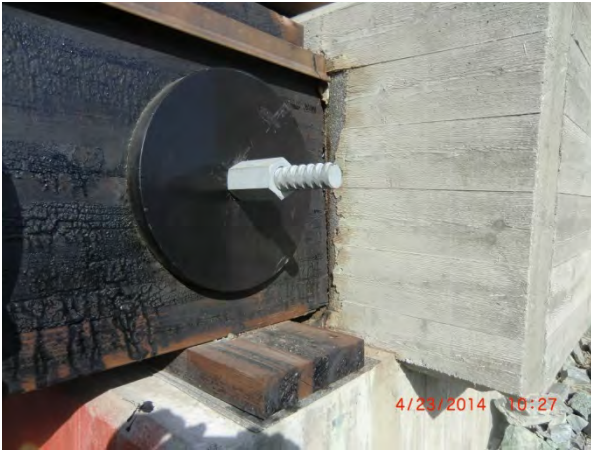
Figure 6: Structural detail which should be evaluated with respect to water trapping

Edges and abutments should be designed with particular attention to avoid standing water. It could be useful create a little gap between the timber lamellas and the concrete to prevent water traps. Moreover, the joint between timber and concrete is also easy to inspect (Figure 8) [6]. However, this might necessitate changes in design as contact between the materials is often used to transfer both horizontal and vertical forces. In Figure 7, there is a gap between the parapet and the plate on the outer lamella. This allows the water to fall down preventing the accumulation of water on the detail. It will also ease more rapid drying of wetted wood.

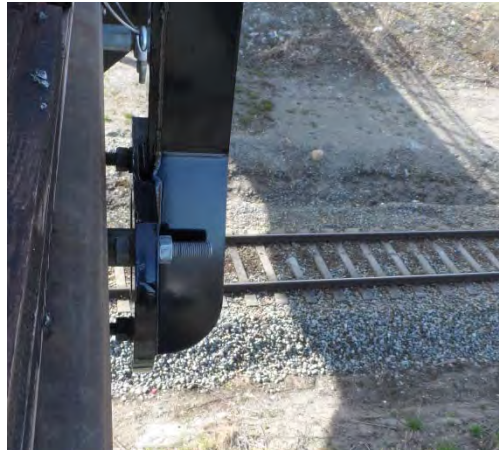
Figure 7: Good detail with respect to standing water

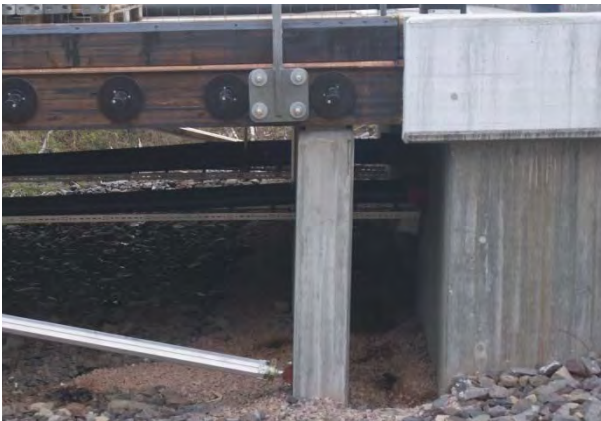
Figure 8: Free space below intersection between timber and concrete (Åsta bridge)

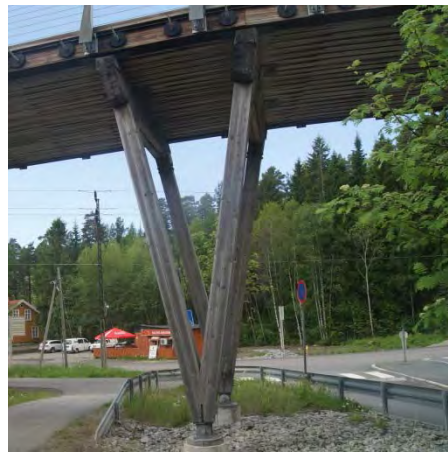
Figure 9: V-shaped column (Sørliveien bru)

V-shaped columns appear in several bridges, often due to structural reasons, but their design with respect to moisture trapping and on durability of timber should be evaluated. Water slides down through the column and it can be captured and stand in the concavity, increasing the moisture content. It could be useful to protect the inner face of the column in the proximity of the joints with physical covering. The cladding is commonly used to protect inclined frames near the connections, as it is shown in Figure 10.

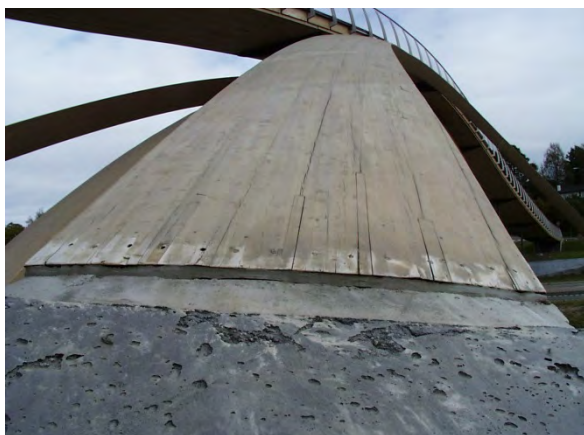
Figure 11: Arch of Leonardo Bridge before the cladding (NPRA)

(copper, zinc) cladding. An example of cladding can be found in the Leonardo da Vinci Bridge (see Figures 11 and 12). The cladding was inserted after the appearance of fungi caused by the water entering in the cracks.

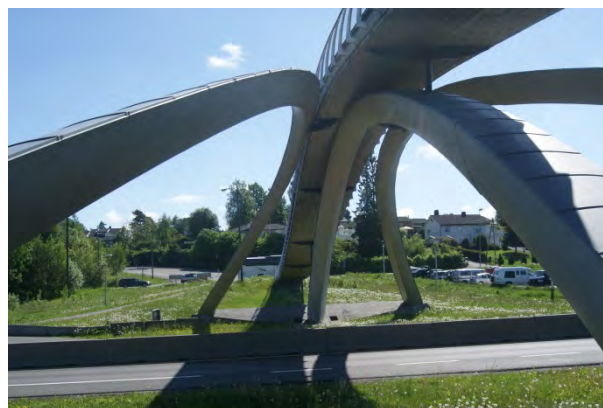
Figure 12: Arches of Leonardo Bridge after the zinc cladding

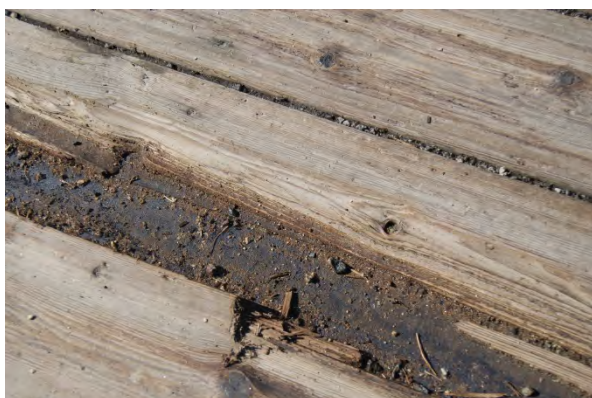
The next pictures show examples of bridges, in which the deck is not covered with a membrane. It is possible to see the damage suffered by the timber lamellas due to standing water, even if they were treated with creosote. For this reason, open decks are not more used in new bridges.

Figure 13: Damage on deck due to standing water (Måna bridge)

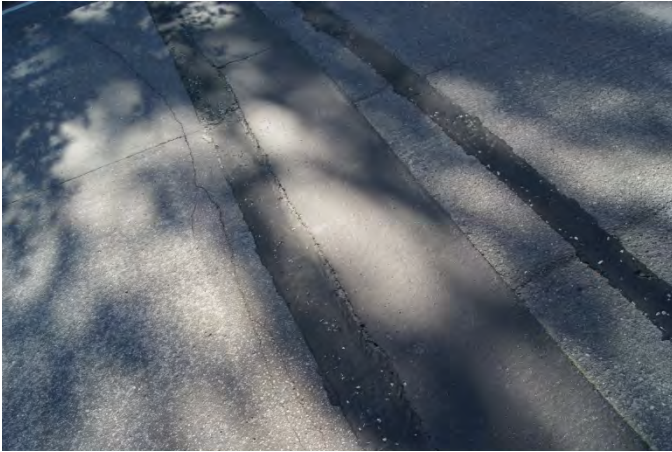
Figure 15: Støpeasfalt (left side) used on Møllendammen bridge

One of the most common membranes is the “Topeka”, which is a mixture of dried and heated stone material and bitumen and gravel, used also for wearing course that have to sustain heavy traffic level. But often Topeka might be softened by the creosote oil and for this reason it can be pushed aside by the tire pressure or braking forces can push the wearing course. Another used membrane is the “Micorea”, a polymer modified membrane, but blisters have been experienced and this can lift the asphalt layer. One of the modern technologies used is the combined mastic asphalt (Støpeasfalt) that has a higher content of filler than Topeka [10]. This is more stiff than usual and could crack in the winter but for the moment there is a limited experience to evaluate if it is watertight when this happens.

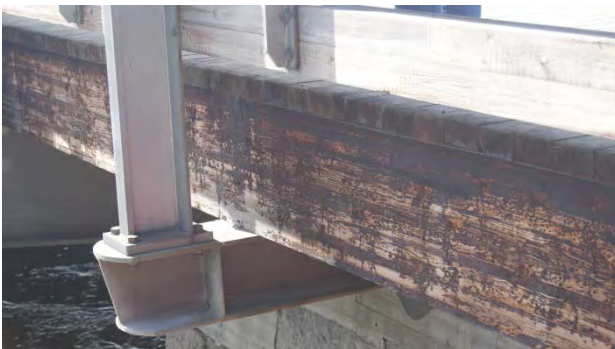
Figure 16: Structural detail which should be evaluated with respect to accumulation of dirt

Water traps or weather conditions are not the only cause of elevated moisture content in timber. It should be paid attention on the cleanliness of the bridge. Indeed, dirt, debris or vegetation can raise moisture content of timber, if they are in its proximity. Structural details should be evaluated in order to prevent accumulation of moisture trapping materials close to the bridge. Furthermore, in order to guarantee lifetime, a good maintenance is recommended.

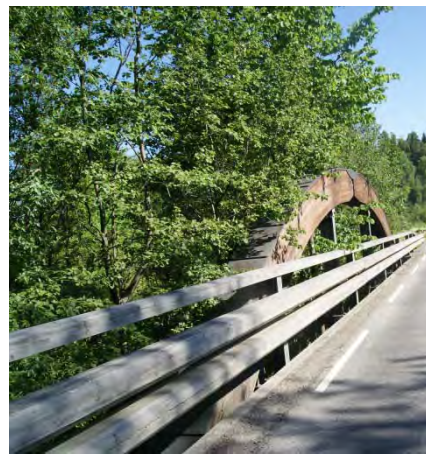
Figure 17: Vegetation touching the timber elements

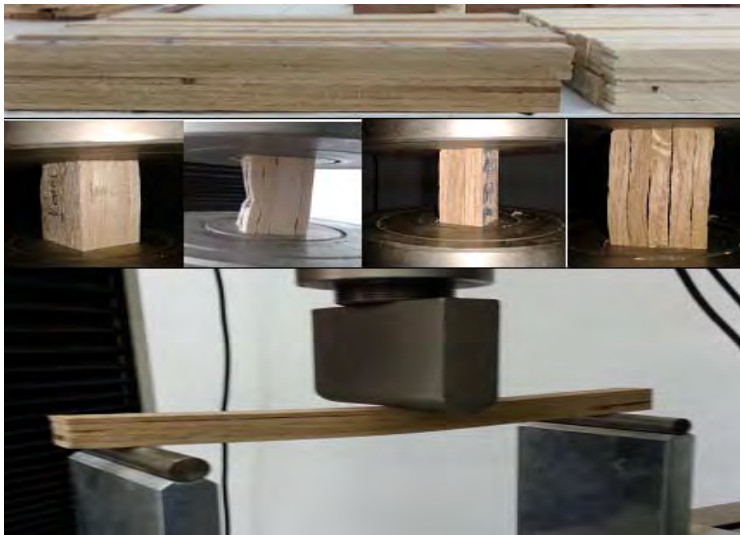
Figure 1. Test samples and Mechanical test procedure

Density, swelling/water absorption for 24 hour tests were determined with Turkish Standards (TS) TS EN2472 and TS 4084. Flexural strength (FMOR), modulus of Elasticity in flexure (FMOE) and compression strength (CS) were determined according to related standards of TS 2474 and TS 2595, respectively. The mechanical test procedure was shown in Fig.1.

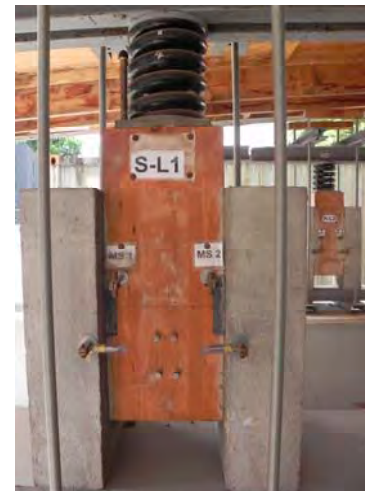
Figure 3: Long term test

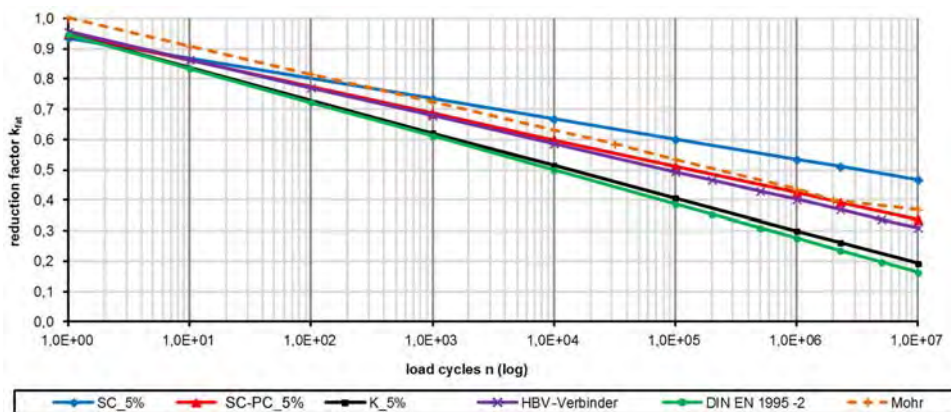
Figure 4: Fatigue curves of several TCC connections [7]

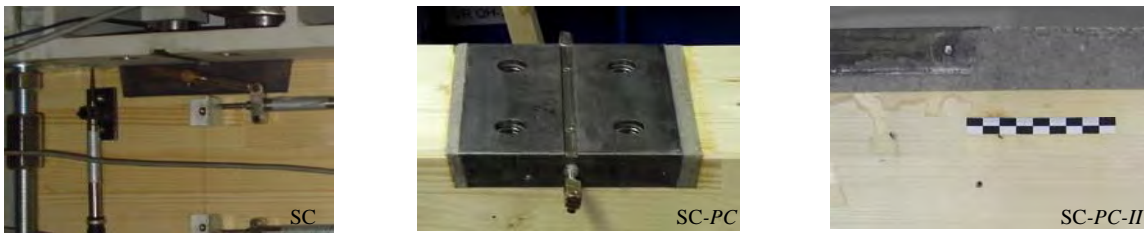
Figure 5: Stud connector placed into the timber with direct contact (SC), filled gap (SC-PC), embedded into PC (SC-PC-II)

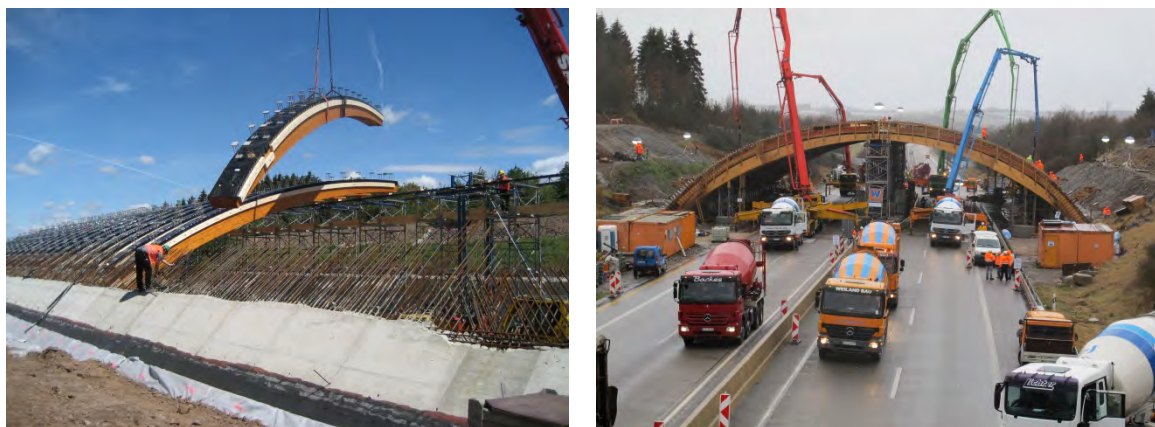
Figure 6: Building progress: adjustment of the timber ribs (left side) and concreting (right side) (photos: K.-H. Lorbach)

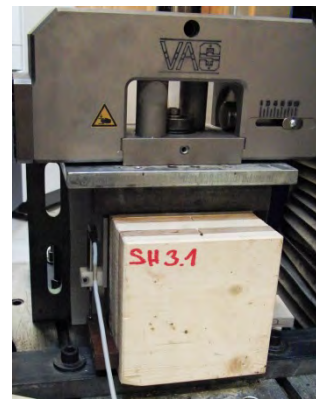
Figure 5: Detail of the test machine readied for a shear test

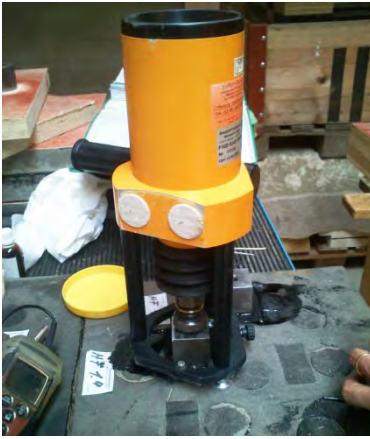
Figure 7: Mobile adhesion tensile testing machine of the company BTS Baucontrol

The mobile testing machine used has a stamp-like head called “indenter” which pulls the test specimen from the wooden base. The surface of the test specimens needed to be properly prepared so that they could be glued to the indenter of the testing machine. The PBM polymer bitumen membrane was heated with a Bunsen burner so that the top-most layer of sanded epoxide could be removed. The primer of the LSS liquid synthetic sealant was removed with alcohol.

A layer of cyanoacrylate adhesive was used to attach the test specimen onto the indenter of the testing machine. The testing area of the surfacing was cut free from the surrounding surfacing area, so that only this area was subjected to the pulling force (Figure 7, Figure 8). The tests were carried out in the laboratories of the Bern University of Applied Sciences in Biel by the company BTS Baucontrol. The tests were force-regulated at a rate of 300 N/s.

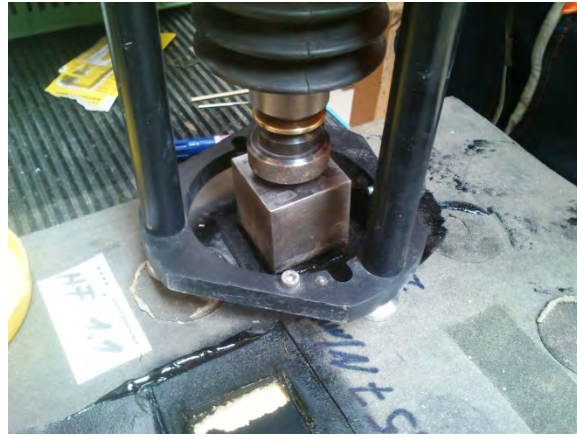
Figure 8: The indenter is pulling at the barely visible PBM sealant underneath it

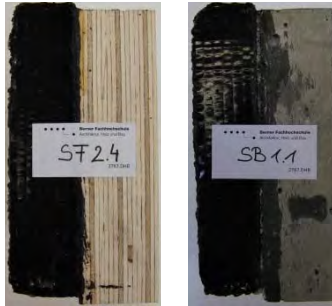
Figure 10: Plastic deformation of a test specimen with PBM sealant on CLT (left) and on concrete (right)

The test results showed different load-bearing behaviours for the two sealants used. Layer compositions with polymer bitumen membranes (PBM) exhibited very ductile behaviour: the yield shear stress of 0.2 - 0.6 N/mm² was attained at an elastic deformation of 1 - 2mm. The plastic deformation after the yielding was considerable: the tests were stopped after a deformation of 10 mm was attained (Figure 10). After the tests, the elastic deformation of the specimens was slowly but fully recovered after a few days.

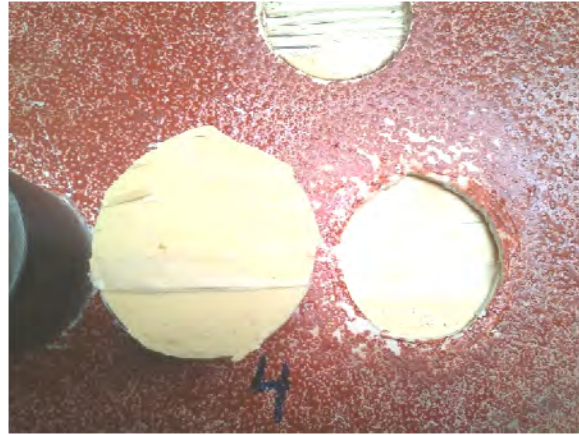
Figure 17: Test specimen with LSS sealant after successful adhesion tensile test [5]

All test specimens fulfilled the adhesion tensile strength requirements according to the standard SN 640450a:2009. Figure 16 and Figure 17 show two test specimens after the adhesion tensile tests. The evalua-

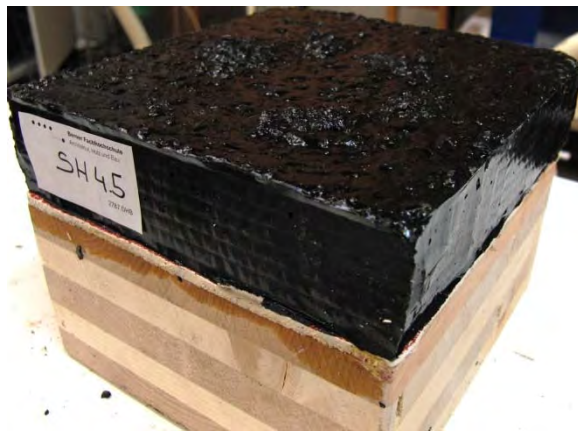
Figure 21: Clear blistering in the surfacing of this specimen of asphalt surfacing on CLT

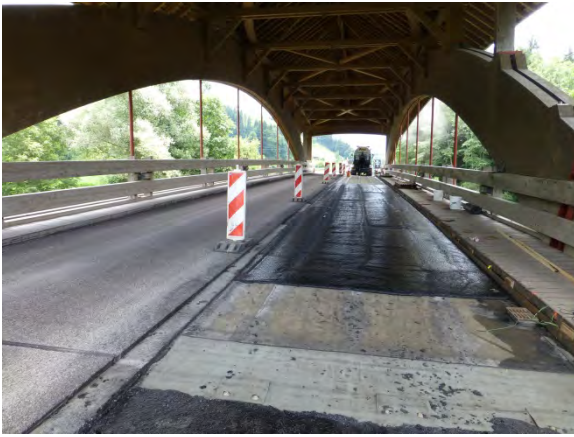
Figure 25: Picture of the Bubenei Bridge during the asphalt coating

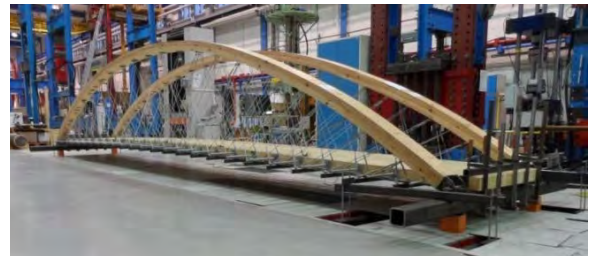
Figure 5: Laboratory model of the bridge

The scaled experimental model has close resemblance to the scaled numerical model and has been used to explore the real behaviour of materials and connections. So far, two dynamic test series have been performed on the model, with the use of the modal hammer method. The first series was performed directly after erecting the laboratory model in order to quantify the structural behaviour. The achieved results suggested need for experimental model modification. The modification consisted of pre-stressing the hangers and improving the deck support by clamping. These actions led to better dynamic response of the structure (natural frequencies and corresponding mode shapes and damping ratios). Simultaneously to laboratory research, numerical models were prepared and evaluated, [5] [6].

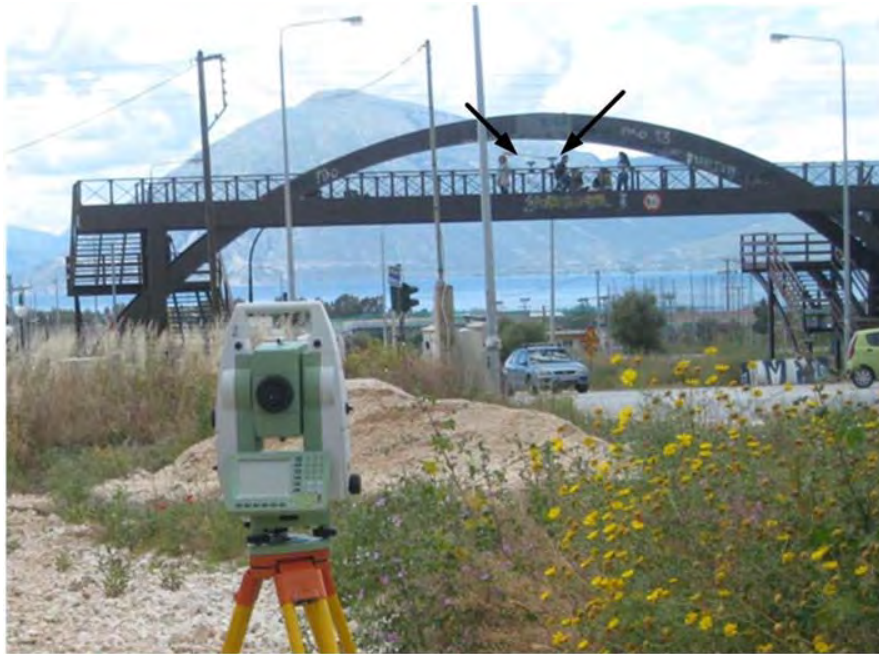
Figure 1: Side view of the Kanellopoulos pedestrian timber bridge in Patras. A Robotic Total Station (RTS) is shown in the foreground, while arrows indicate collocated sensors, including RTS reflectors and accelerometers.

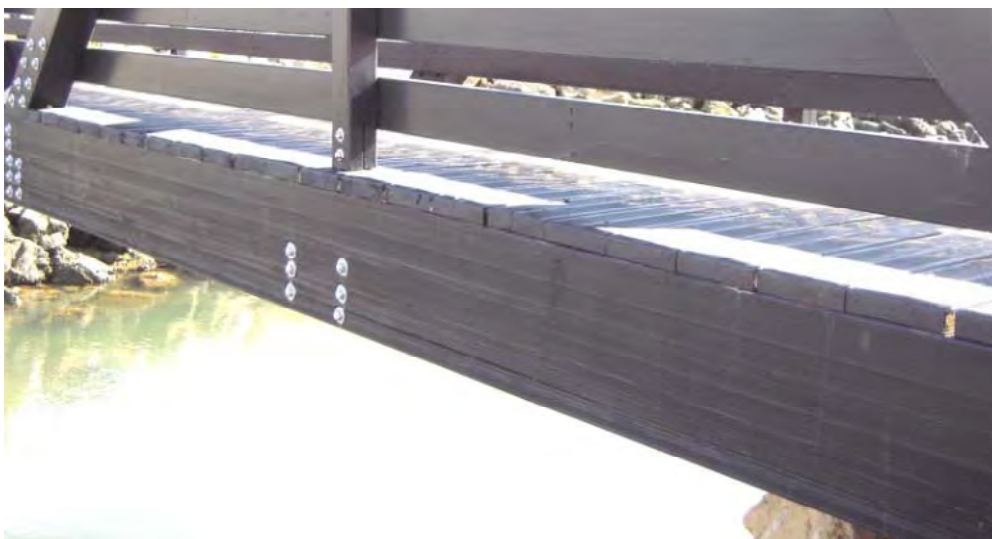
Figure 2: Crack of the timber member

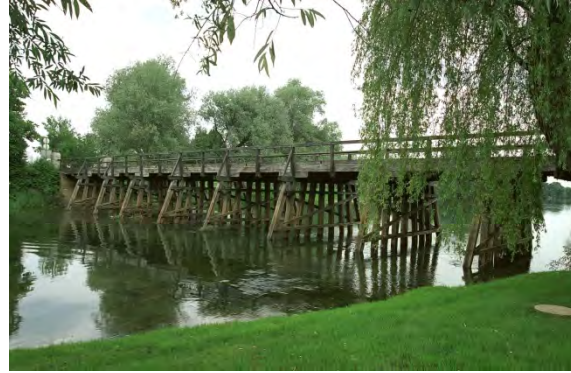
Figure 5: Kostanjevica na Krki: south bridge

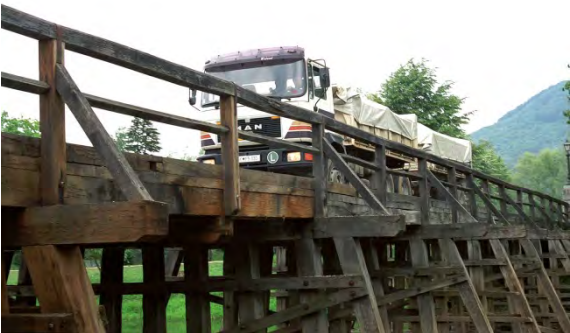
Figure 6: Trucks overloading the bridge.

The inspection summary rates the structure with numerical value 23.12 and with codified bridge condition as 3 (satisfying condition). The assessment report concludes that only urgent maintenance work was done since the previous regular assessment. Report also lists the standardized measures (fixation of dilatation profile, fixation of deck planks, and reparation of railing, removing the river debris) and urgent repair / repair with deadline (rehabilitation of pillars). The overloading is exposed as a special measure which should urgently be dealt with.

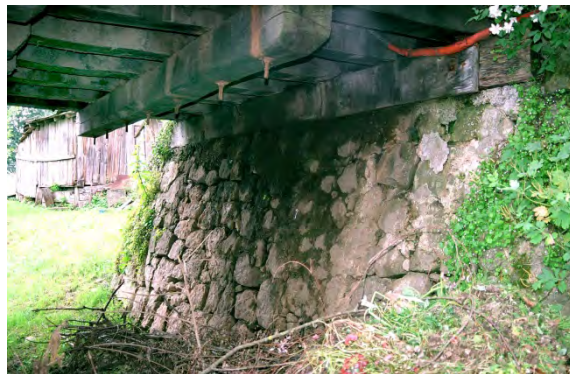
Figure 7: Corrosion of steel and cracks in stone pillar

Piles were in relatively good shape – regardless to the river debris which can be found at almost each inspection (Figure 9). There were some bracing elements identified which have to be replaced. Steel connection elements (bolts, and clamps in deck structure) were corroded and often have to be retightened. The level of deterioration of pile caps is commonly relatively high (Figure 8). This might (also) origin from bad connection detail of bridge railing support. Pile caps are consequently under fungi attack (Figure 8). The same conclusion is valid also for the main bridge beams and for the lower deck (Figure 12). Elements of upper deck commonly have to be retightened, (Figure 13). Bridge railing commonly presents relatively deteriorated member, some parts may also be missing (Figure 11). Minor cracks were also identified in main structural elements (main bridge beams), but these fissures mainly originate from drying process.

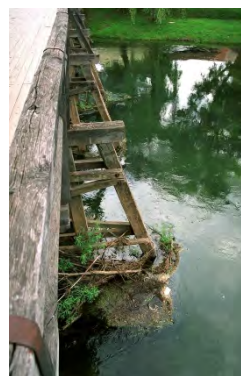
Figure 9: Deteriorated railing and river debris

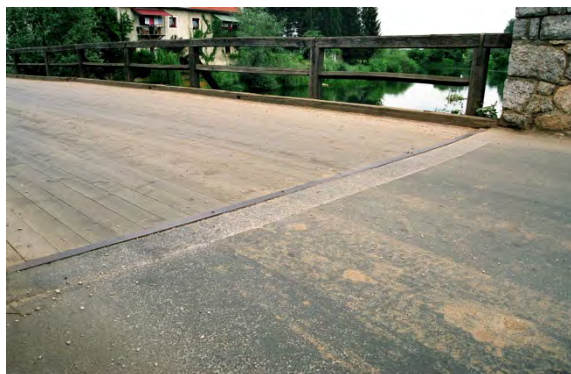
Figure 10: Dilatation profile needs retightening

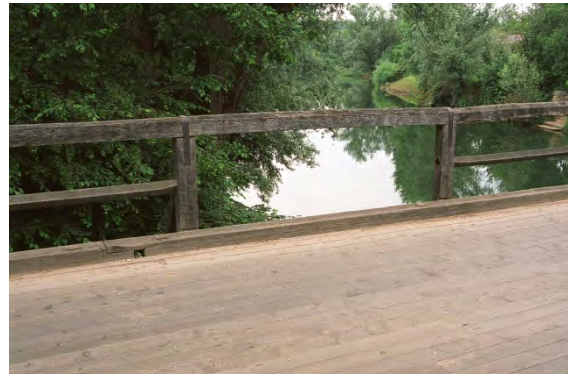
Figure 11: Part of railing is missing

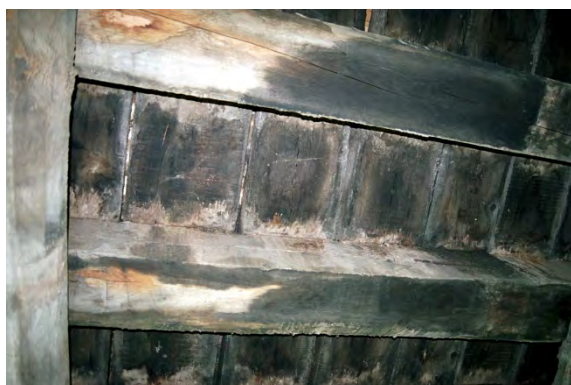
Figure 12: Fungi attack - main beams, lower deck

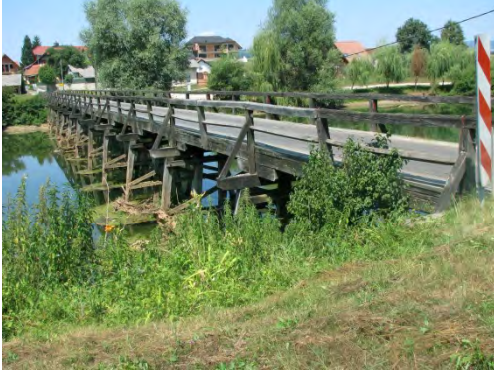
Figure 14: timber bridge over Krka river in Loke

The result of detailed inspection is a report including the detailed description of damaged elements that need to be replaced or their graphical representation [6]. Although the structural system is similar to the previously presented assessment case, the deterioration level with the second assessment case, timber bridge over Krka river in Loke, is much higher (Figures 14-17).

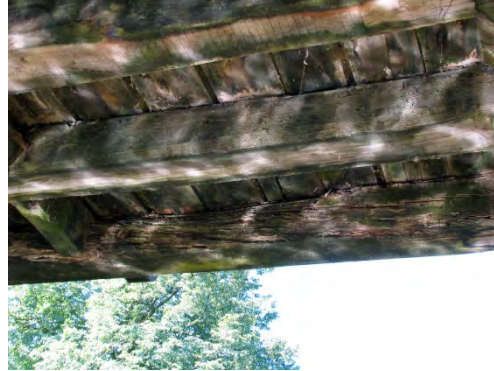
Figure 15: Deteriorated main beam

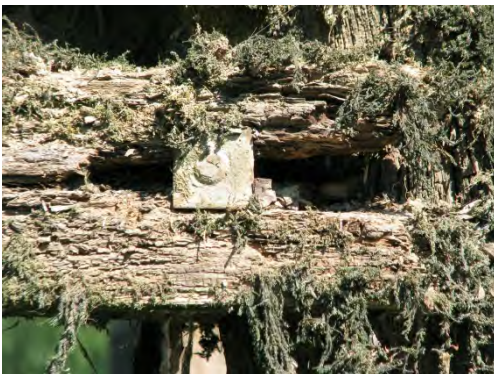
Figure 16: Connection detail

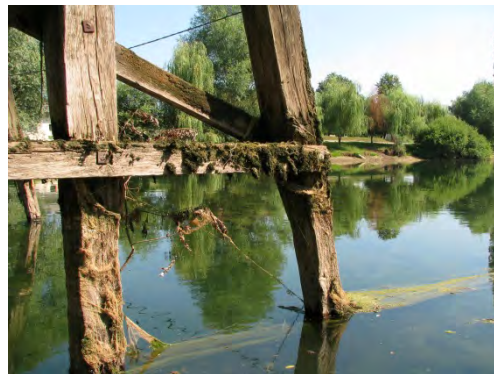
Figure 17: Reduced cross section of pillars

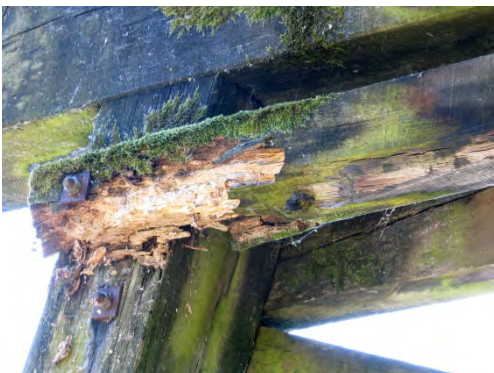
Figure 18: Deteriorated tie beam

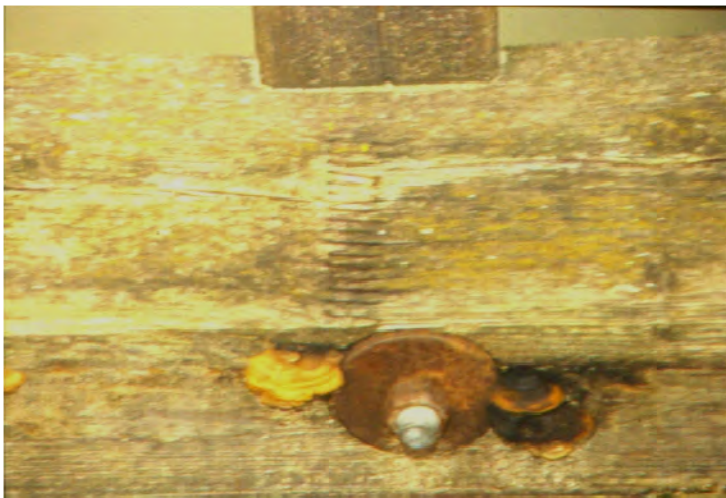
Figure 1: Timber-bridge n. 9. Fruiting bodies of brown-rot fungi, close to moisture trap (hole, bolt and washer).

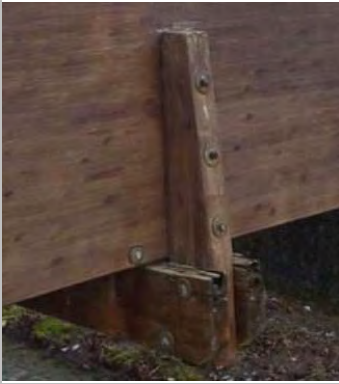
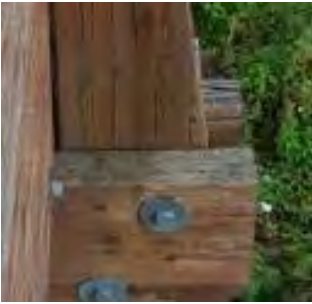
Table 2 – Exemplification of the main problems discovered on timber footbridges and relative images. Selected bridges characterised by incoming decay.

N.	<i>uncovered horizontal surfaces in load-bearing glulam com- ponents</i>	<i>moisture traps</i>	<i>decay: diffuse in 3 e 9 localised in 1, 6 and 10</i>
1

5 bridges (1, 3, 6, 9, 10 - 42% of the total) were already showing a decay by brown-rot fungi; concerning the diffusion on timber members, decay was localised only in some specific timber members in bridges 1, 6 and 10, but with important local wood degradation and some easily visible fruiting bodies (Table 2, decay column, bridges n. 1, 6 and 10), showing the good development of the alteration organisms, while in bridges 3 and 9 the degradation was very severe and diffuse. All the 7 remaining footbridges were recent (R in Table 1) and so no sign of decayed wood was present. Nevertheless it has to be noted that the low durability of the wood of the beams (Norway spruce and silver fir are in the Durability class n. 4= low durable [5]) to the fungi alterations, expose them to high risk of decay: we can hypothesize that the decay will appear soon.

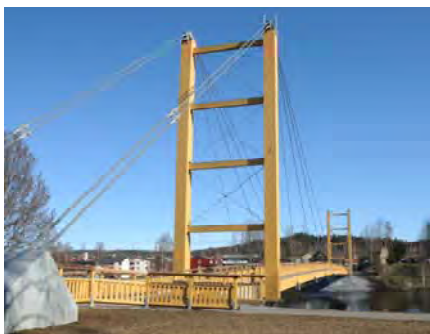
Figure 1: The Älvsbacka Bridge

Many timber bridges have been built in Sweden during the past 20 years. In general, the health of bridges is assessed by visual inspections at regular intervals. Continuous measurements could complement the inspections to provide a basis for the scheduling of maintenance activities. A research project with the overall objective to develop monitoring tools for timber structures to guide the planning of maintenance was carried out in conjunction with the construction of a new bridge. The bridge is passing over a river and it was built as a cable-stayed bridge spanning 130 meters. It is a slender and complex structure and was an object where sensor systems could be installed during the construction of the bridge. In the late summer 2011 the bridge was taken into use, named “The Älvsbacka Bridge”, see Figure 1.

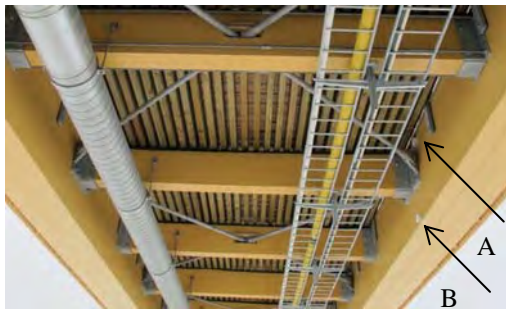
Figure 2: Bridge from underside with sensors

Point	Position	Distance from foundation
A.	Beam inside, top	7.2 m
B.	Beam inside, bottom	7.2 m
C.	Beam outside, bottom, behind cladding	12.6 m
D.	Pylon, halfway up, partly behind cladding

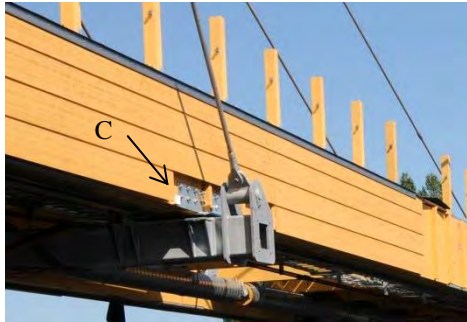
Figure 4: Moisture sensor on beam outside, bottom (C)

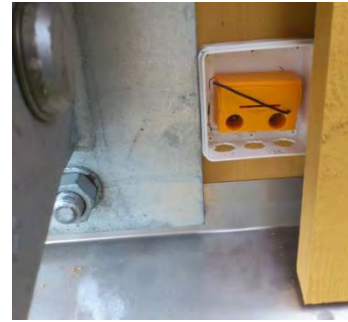
Figure 5: Moisture sensor on pylon (D)

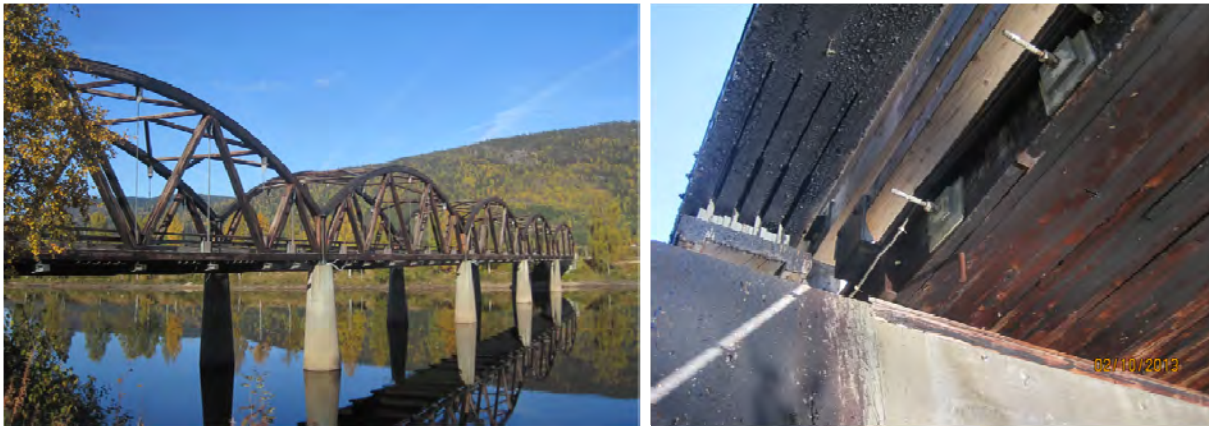
Figure 1: Left: View of Evenstad bridge. Right: detail of the stress laminated deck.

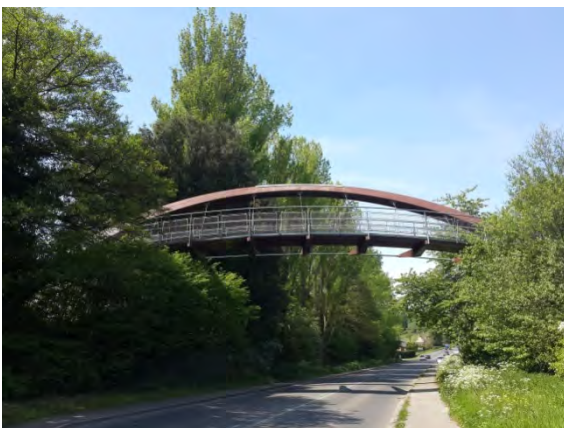
Figure 2 Black Dog Bridge from the road

In this paper, we have selected two bridges to measure the vibration, the Black dog Bridge in the UK and the Knight Ferry Covered Bridge in California, US. The Black Dog Bridge (Figure 2 and Figure 3) is located in Wiltshire, UK, one of the Millennium bridges in the area. The bridge spans 40 metres across the A4 road and is part of the National Cycle Network. It has a lightweight 2.1 metre width deck supported by a Glulam parabolic arch with a section of 675x675 mm and concrete foundations at both ends. The bridge is exposed to the environment with no protection from water and sun and therefore moderate bio-degradation was observed. The combined traffic and human induced vibration is the main source of the structural vibration of Black Dog Bridge.

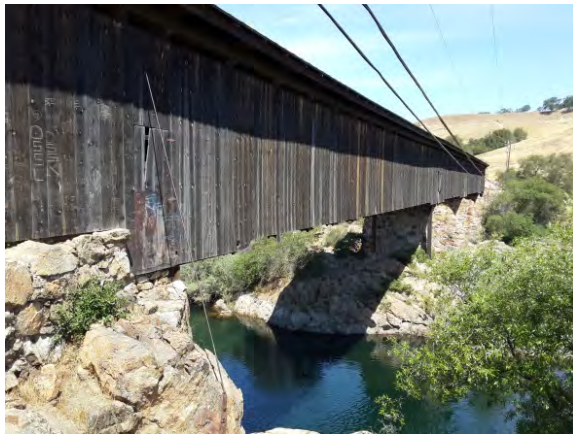
Figure 4 Knight Ferry Covered Bridge from outside

The Knight Ferry Covered Bridge (Figure 4 and Figure 5), a trussed and covered bridge, was completed in 1864, and is located in Stanislaus County, California. It features the longest covered bridge in California with a span of 100 metres, supported by two piers at both ends. The bridge is currently restricted to passenger access due to the discovery of structural safety issues, and has steel reinforcement. Its timber members are well protected by the cover.

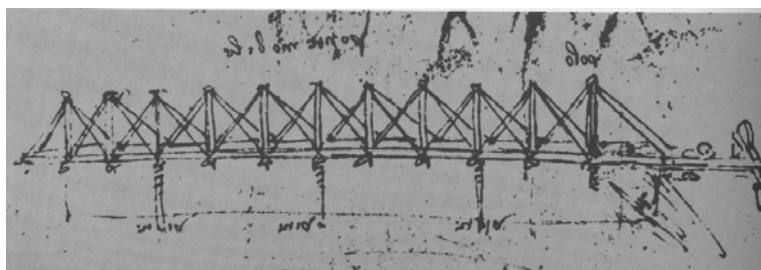
Figure 1 Ponte speditivo, Leonardo da Vinci Figure 2 Bridge on intermediate poles, Leonardo da Vinci

Leonardo da Vinci designed wooden bridges that still nowadays we identify for originality of composition and of typology. He can be considered the true “father” of wooden bridges. The drawings of Leonardo show with great rationality the tie elements - mentioned as cables or wires - and compressed elements - identified as real struts-. Some of Leonardo’s bridges drawings are in a single span and have a crown that could almost be defined as arch bridges (Fig. 1). These drawings precede that of Palladio, but to Leonardo must be attributed the idea of the geometric support as a reason of the mechanical strength: the triangular mesh, the mesh structure (Fig. 2).

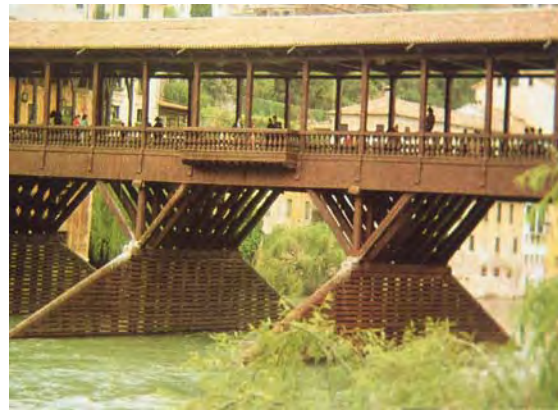
Figure 6 Photo of the Brenta Bridge in Bassano nowadays

The functionality of the typology to connect the two sides of the river and at the same time the elegance of the building, are the result of the absence of a number of struts and of the harmonious relationship between the size of the struts forming the structure. In addition, the use of modularity and prefabrication allows a faster construction phase: disassembling and eventual replacements are simplified by such characteristics.

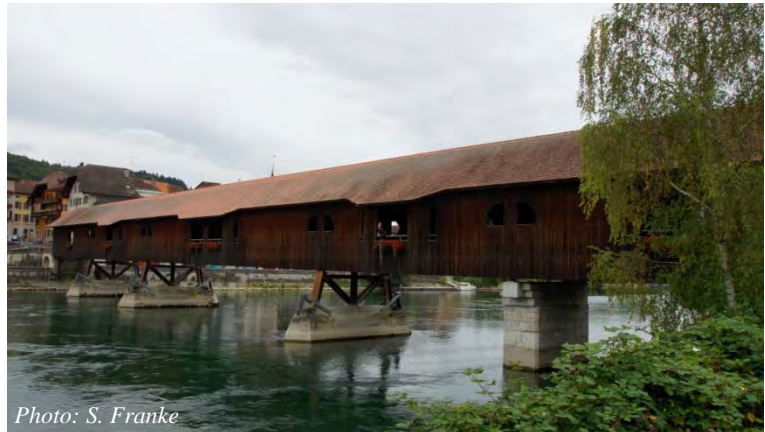
- Built: 1821
- Covered bridge
- Truss frame
- Max load: 16 tons
- Length: 107 m
- Width: 4.8 m
- Height: 3.7 m
- Asphalted roadway

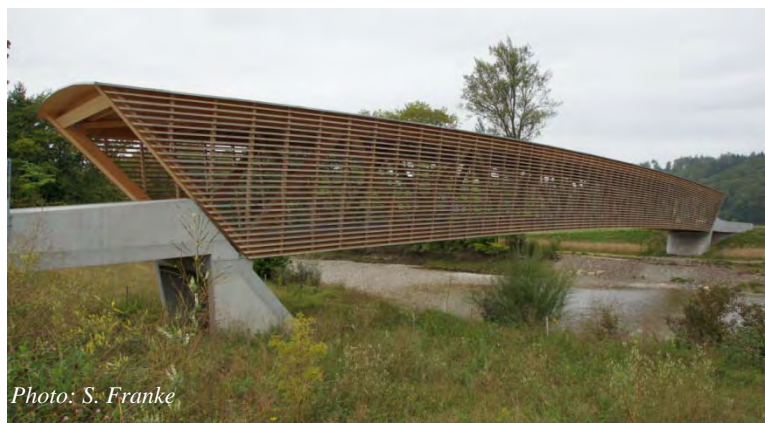
2 Neumattbrücke

The Neumattbrücke is located in Burgdorf and features following specifications:

- Built: 2013
- Covered bridge
- Framework
- Span: 59 m
- Width: 3.8 m
- Height: 3.6 m
- Oak decking roadway

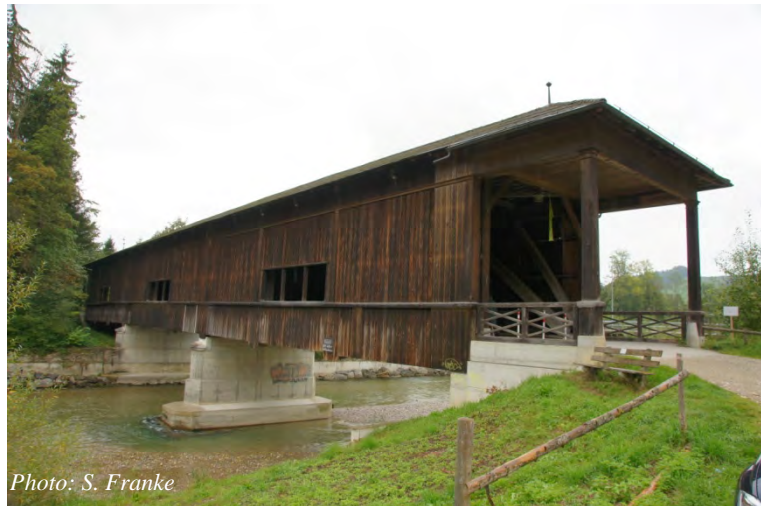
3 Gohlhausbrügg

The Gohlhausbrügg is located in Lützelflüh and features following specifications:

- Built: 1584
- Covered bridge
- Max load: 28 tons
- Length: 61.7 m
- Width: 5.6 m
- Height: 5.5 m

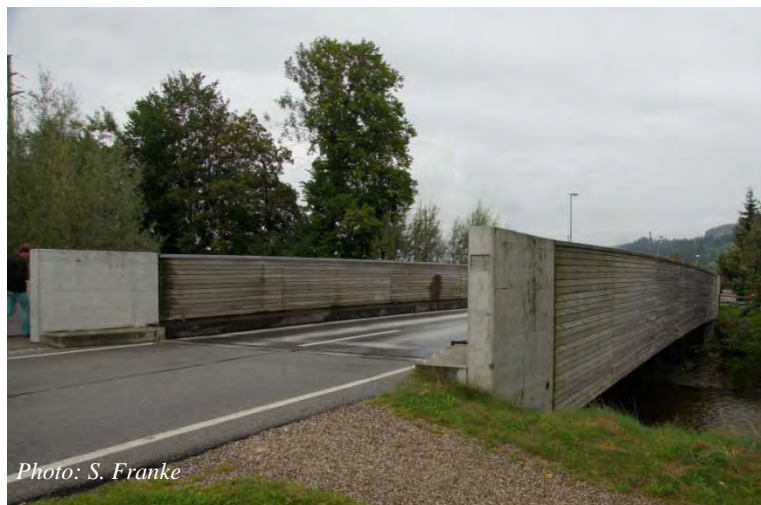
4 Obermattbrücke

The Obermattbrücke is located in Obermatt and features following specifications:

- Built: 2007
- Open bridge
- Max load: 40 tons
- Length: 32 m
- Asphalted roadway
- Lifting bridge at high tide

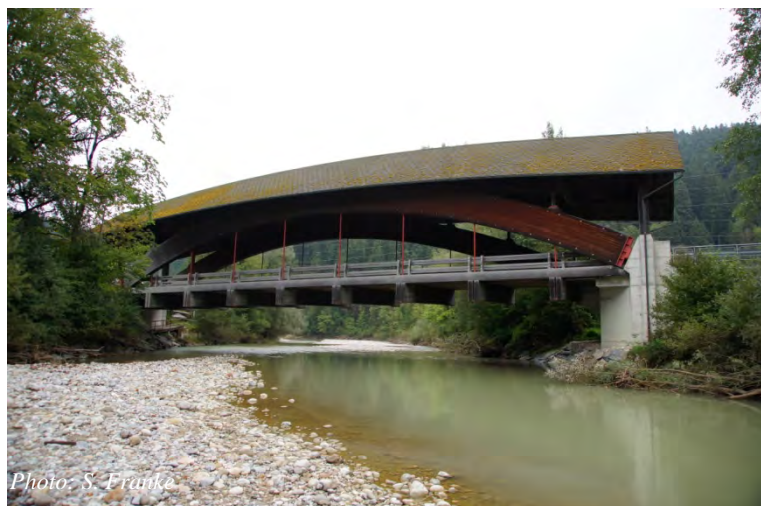
5 Bubeneibrücke

The Bubeneibrücke is located in Signau and features following specifications:

- Built: 1837
- Covered bridge
- Arched girder
- Max load: 28 tons
- Length: 50 m
- Width: 7 m
- Height: 4.5m
- Asphalted roadway

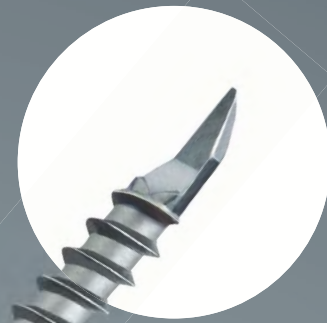
The shape of the new eccentric drilling tip of WT-T fastening system is completely new and unusual. So the new WT-T is faster, more precisely and with a minimized splitting tendency. It bites into the wood effortlessly and offers significant advantages.
